Use of Galvanized Steels for Automotive Body - Car Survey Results at Coastal Areas, Mumbai

Abstract

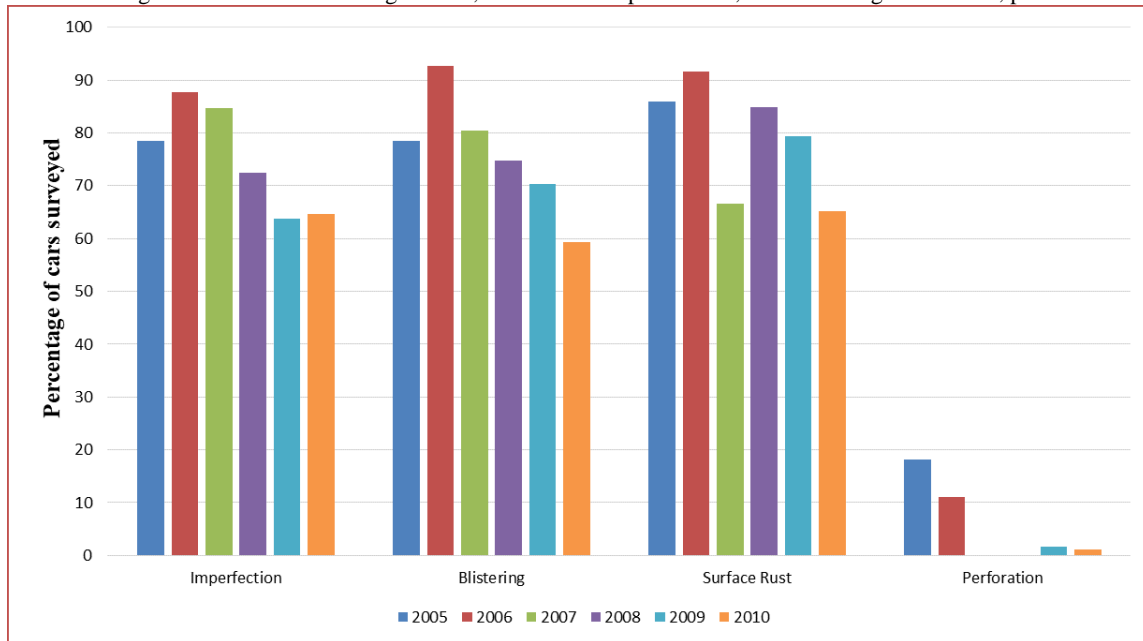
Fig. 4: Graphical Representation of the Survey Summary According to Approximate Ages, Quantity (% of Car Inspected) and Imperfection Type

Table 3 summarizes the imperfection type (blistering, surface rust, perforation and total imperfection) found on various vehicles in the survey. Figure 4 graphically illustrates the surveyed data into three imperfection types and the total number of imperfections. Since 5-9 year old vehicles had the most statistical significance, vehicles older than these have been ignored because of the small sample size.

As expected, the number of vehicles exhibiting a certain imperfection tends to increase with the increasing age of the vehicles. It is also quite evident that the number of blisters and surface rust were more predominant than perforation.

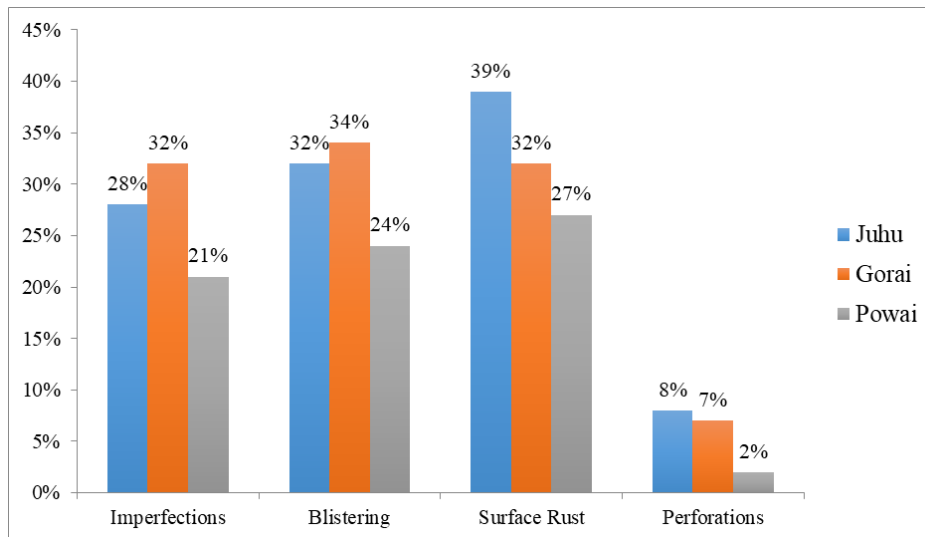
Fig. 5 Bar Chart for the damage due to various defects on three sites surveyed.

It is quite evident that perforation was not an issue of concern while blistering and surface rust are major detrimental features. Out of the four major parts inspected, rocker panel exhibited the highest damage in terms of number of imperfections, blistering and surface rust. This can be attributed to its closeness to the ground and hence effects of road debris, stagnant water, etc. The surveys related to three individual sites, viz., Powai, Juhu and Gorai is indicated in Fig. 5

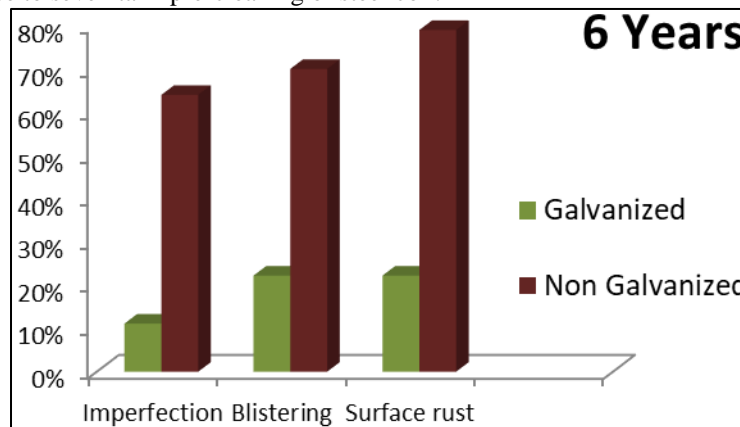
Fig. 6: Comparison of Corrosion of Two Cars, One using Galvanized Steel and the Other Ordinary Steel as the Car Body

There was another attempt to have a survey on a few high class cars which use galvanized steel as the starting material in comparison to the many Indian cars which use steel coils as starting material. The results are compared in Fig. 6. The survey shows that a car after six years shows higher corrosion on a non-galvanized steel usage while where galvanized Steel was used the corrosion damage was very low.

The use of galvanized steels in automotive not only enhances the life and durability of car, it also helps to maintain the coating facility free from pollution due to seven tank pre-cleaning of steel coil.
